Current MMI3G software update

Data memory entries following software update in "5F-Informationselektronik 1" (5F Information electronics 1)

Back-up documentation following software update unsuccessful

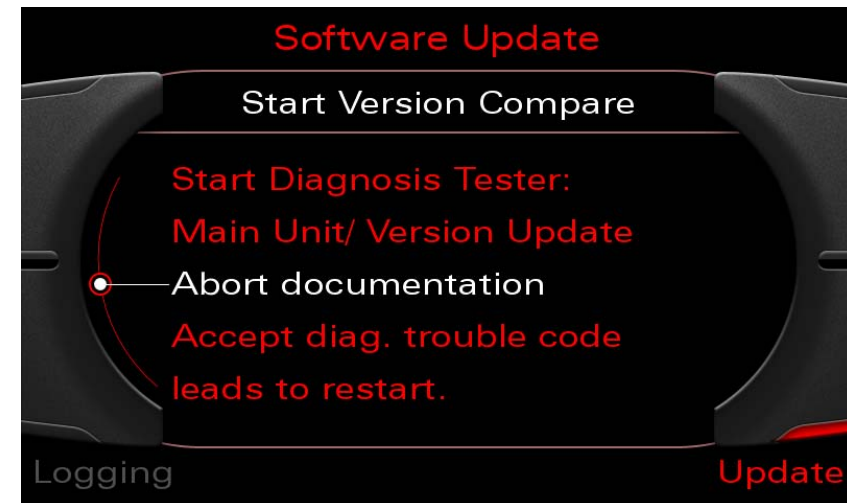
Technical background:

- Control unit 1 for information electronics cannot restart automatically following update and parameterisation.
- The control unit no longer responds to requests from SVM.
- SVM generates the response "Hardware prüfen" (Test hardware) for all other MMI components.

Procedure:

1. The following appears in the MMI display after update:
2. Select "Dokumentation abbrechen" (Abort documentation).
3. The MMI automatically initiates a restart.
4. Wait until the MMI display is populated again.
5. Create back-up documentation with SVM code.
