## Service / Safety-Emergency Disconnects

There are several ways to shut down the <u>high voltage</u> (outside of the battery) in hybrid and electric vehicles. In an article to be released next week, I will cover the various <u>safety systems</u> within the vehicle that "should" shut down the high voltage and thoroughly explain the various safety, emergency and service disconnects that can be used by rescuers to isolate the high voltage to the battery.

In this training I will show the various locations where we can expect to <u>find service</u> and safety / emergency shut offs that can be used to isolate the power.

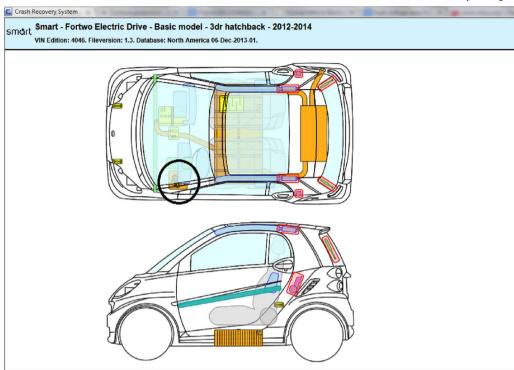
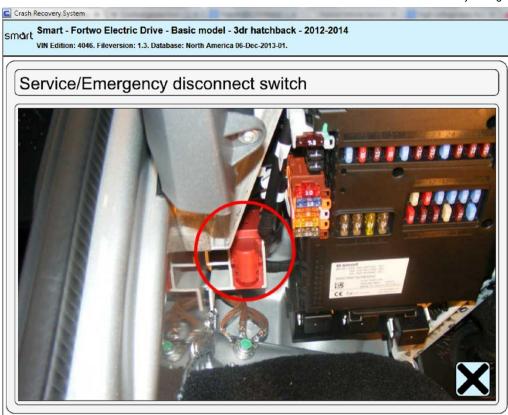
**Smart Car / 2012 – 2014**

(Above) The  $\underline{Smart\ Car}$  – In the first image I have circled the

disconnect on the left side of the steering wheel. This is an uncommon location for a disconnect. In this case the orange plug is removed from the receptacle.

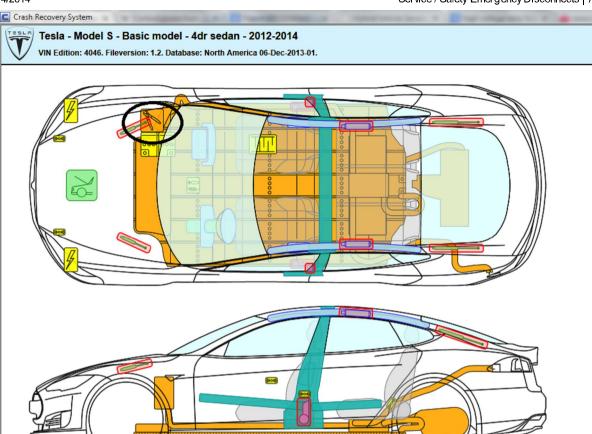
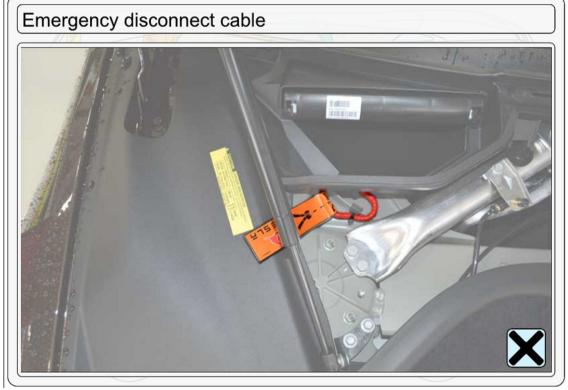
**Tesla Model S / 2012-2014**

(Above) The Tesla Model S – In the first image I have

circled the location of the disconnect. In this case the orange cable is cut to isolate the high voltage. When using the cable type disconnect, be sure to double cut the cable to avoid accidental re-connection.

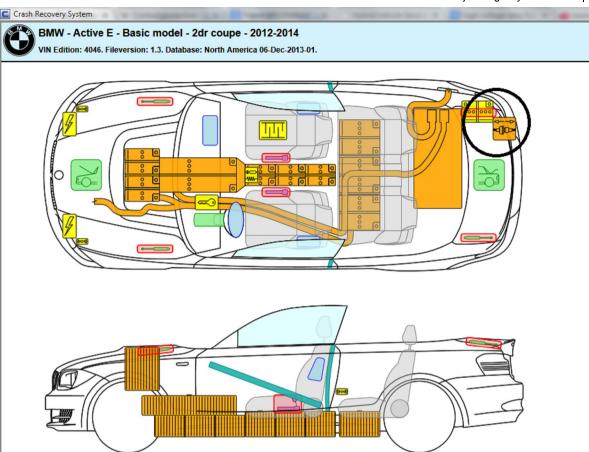
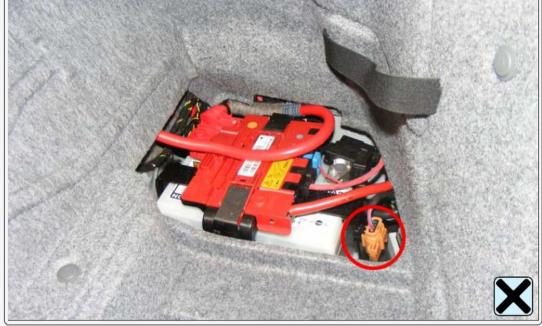
BMW Active E - 2012 - 2014

(Above) BMW Active E-In the <u>first picture</u> I have circled

the location of the disconnect. In this case the orange plug is removed from it's receptacle. In this case the orange plug has a cap like cover that, when removed will isolate the power to the battery.

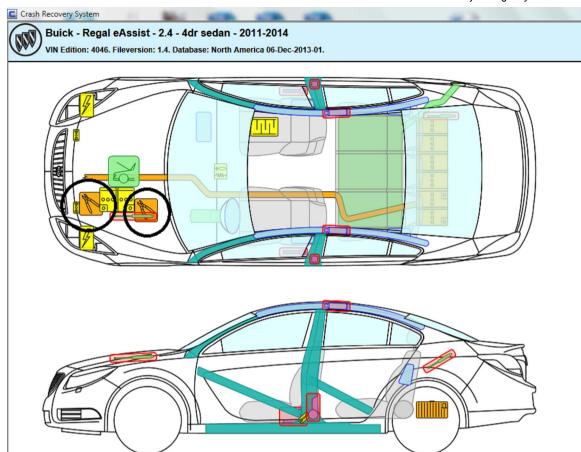
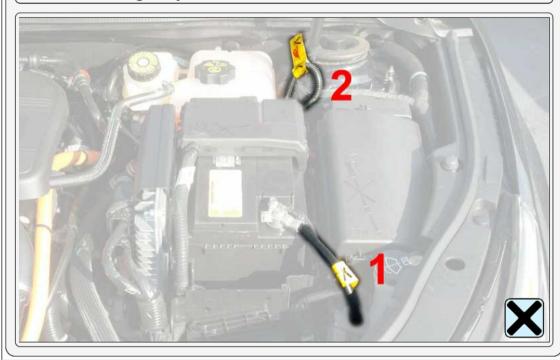
## Buick Regal EAssist – 2011 – 2014

(Above) Buick Regal EAssist – In the first picture I have

circled the locations of the disconnects. In this case the manufacturer is recommending that the emergency cable and the 12V battery cable both be cut for shutdown. As rescuers we know to always follow this guidance and cut the 12V battery cables as common practice at every incident.

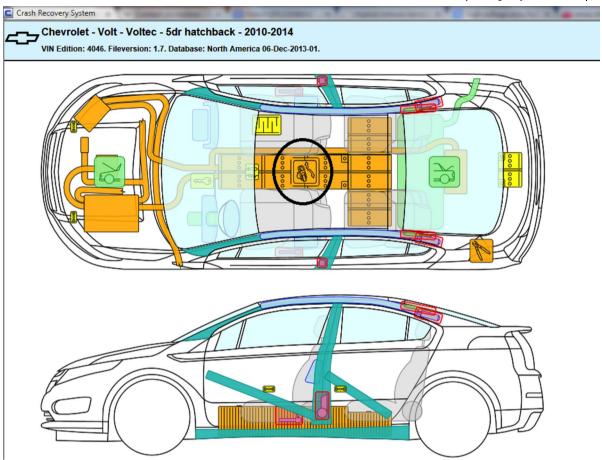
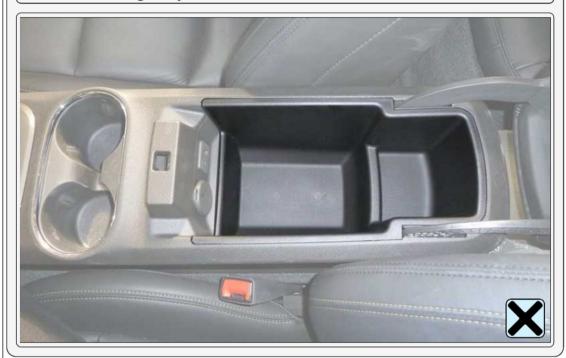
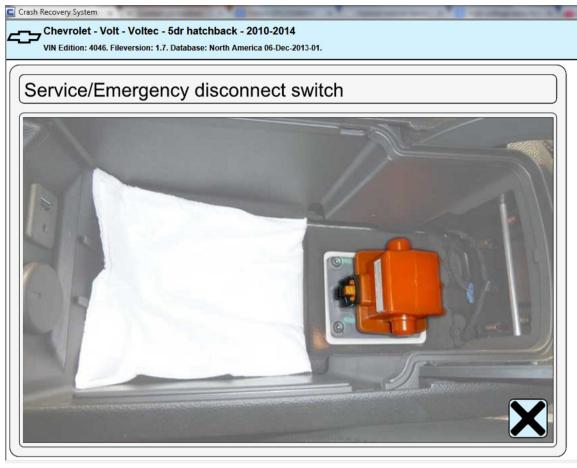
**Chevy Volt – 2010 – 2014**

(Above) Chevy Volt – In the first picture I have circled the

location of the disconnect. In this case the basket is removed from the center console and the Orange component is removed by depressing the bottom on the bottom of the side while the entire unit is lifted.

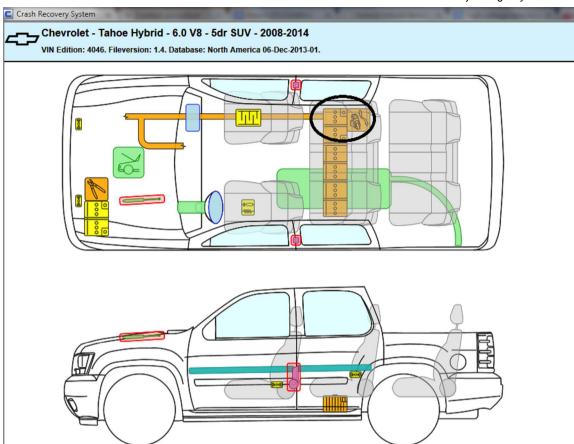
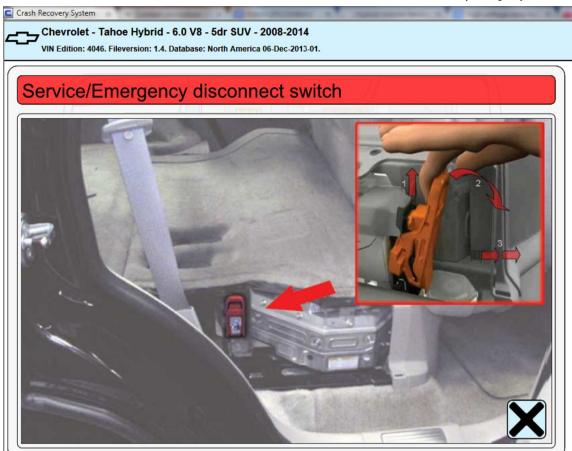
**Chevy Tahoe – 2008 – 2014**

(Above) <u>Chevy Tahoe</u> – In the first picture I have circled

the location of the disconnect. In this case the upholstery on the side of the back seat is stripped away to locate the disconnect. The Orange disconnect is then removed by lifting the handle up, down then out. This is a very common location for the disconnect on a SUV type of hybrid.

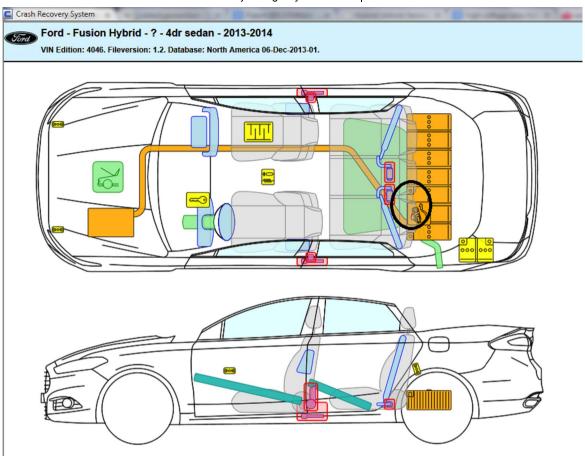
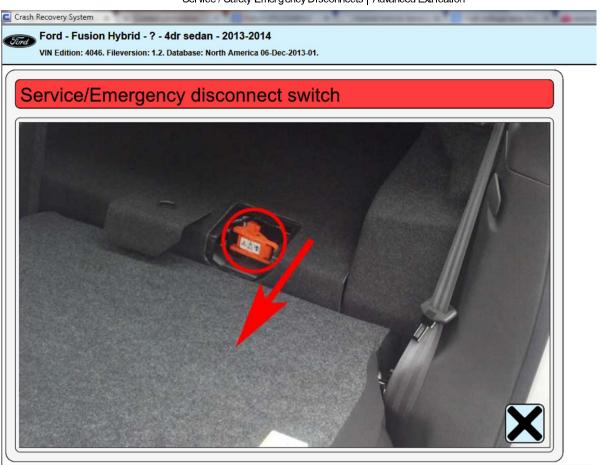
#### **Ford Fusion – 2013 2014**

(Above) Ford Fusion – In the first picture I have circled the location of the disconnect. In this case the disconnect would be very challenging to access if the rear seat back was in the upright position

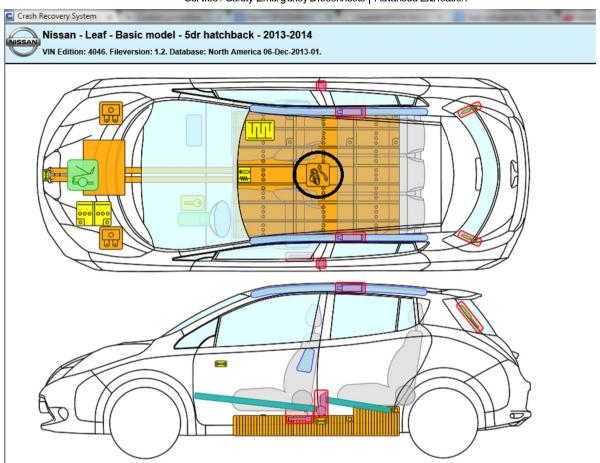
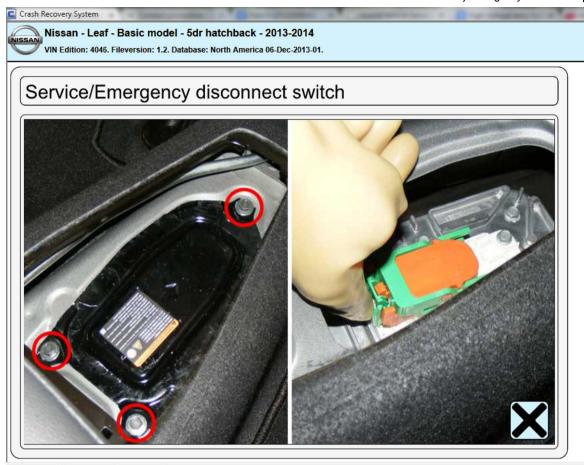
Nissan Leaf - 2010 2014

(Above) Nissan Leaf – In the first picture I have circled the location

of the disconnect. In this case the upholstery in the center
