## Technical.bulletin valeo added IIIIIII

| Rotating Electrics | Alternator | Smart Charging | Ford

## Smart charging alternators on Fords

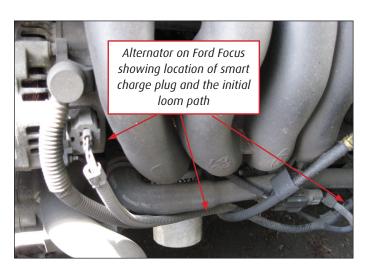
If the battery is of the correct type and the alternator is found to be charging, the next part to check is the continuity of the wiring loom from the alternator to the PCM. Due to the location of the alternator in relation to the PCM, the wiring can become chafed or the insulation melts from being too close to a heat source. This is *a* common *reason* when the battery light is illuminated and a new loom will be needed.

This is listed for the Ford Connect, part no.1421293, but can be modified for other models.
